Making Tierrasanta a Fire Safe Community

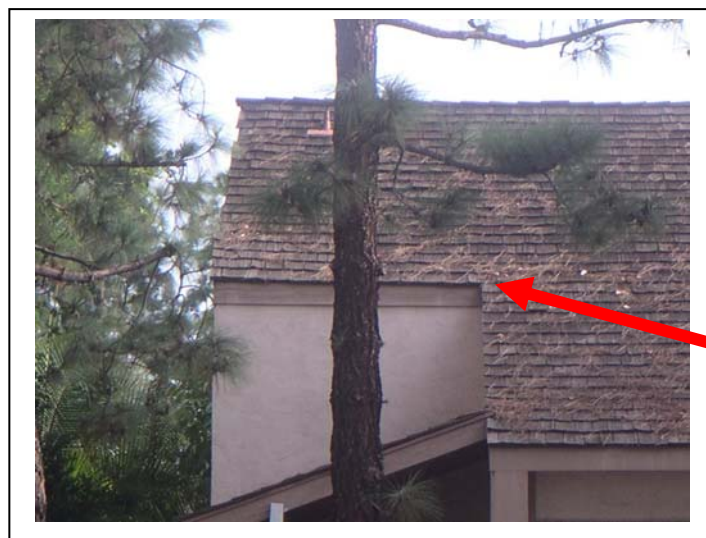
Trees closer than 10 ft from house. Duff on roof

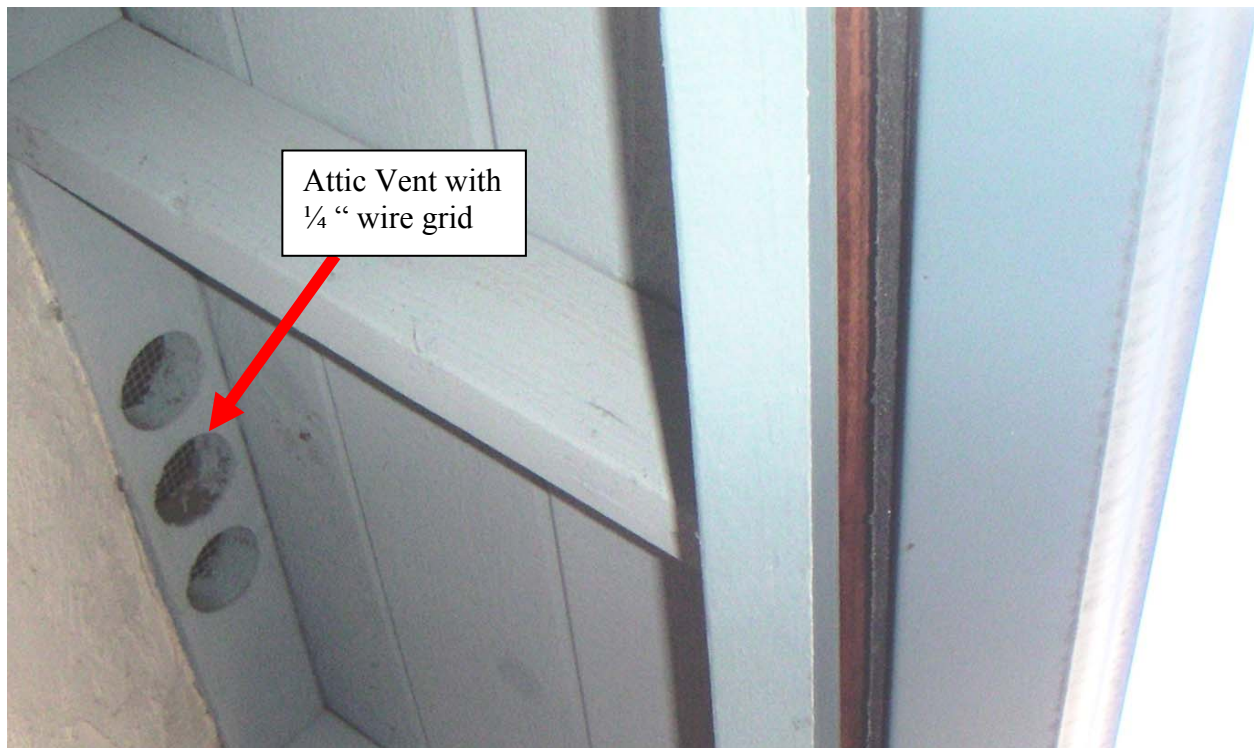
Eaves act like umbrellas in the wind and catch wind with embers and debris as the wind pushes them into any crack, void or vent.

Vents facing the wildland urban interfaces (WUI) to our northeast are particularly susceptible. In Tierrasanta these are our open spaces, canyons, MCAS and Mission Trails Regional Park (Remember the Cedar Fire!). An opening less than $\frac{1}{4}$ inch will allow firebrands to be drawn in. Most homes in Tierrasanta have overhanging eaves with attic vents under the eaves allowing circulation to prevent attic mold. These vents are covered with screening that, in fact, has $\frac{1}{4}$ inch spacing. A recommended screen spacing to block firebrands is closer to $\frac{1}{8}$ inch.

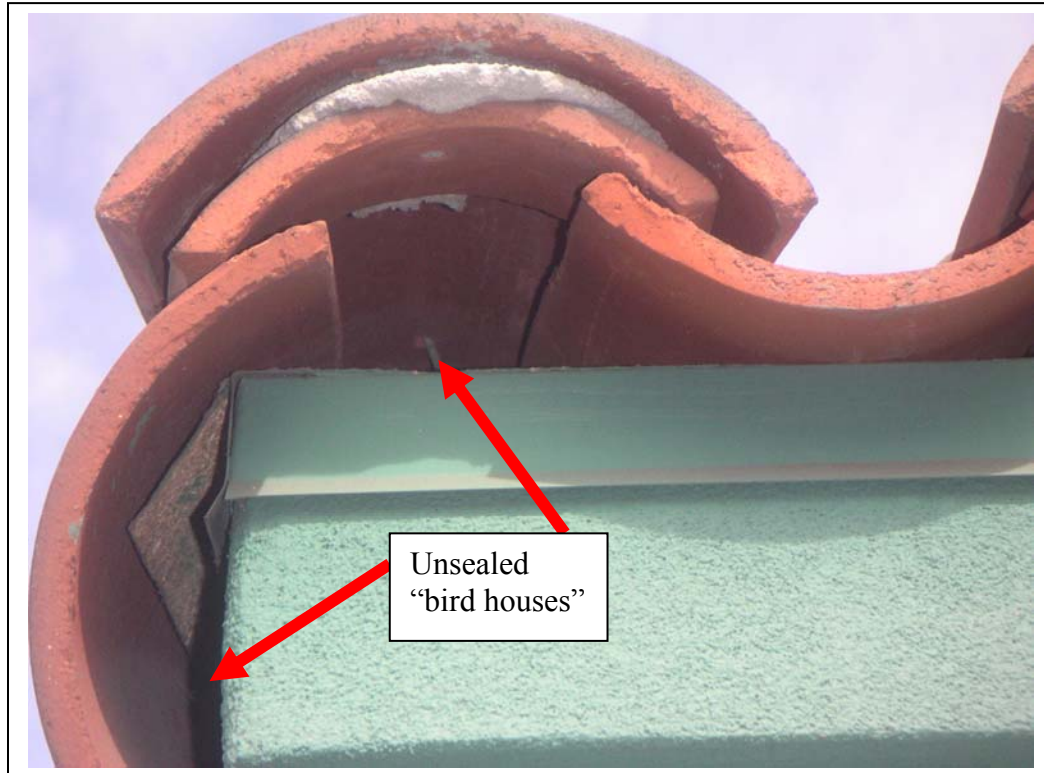
Often overlooked are unsealed roofs. For example, Spanish cement tile roofs have voids between the roof and the tile due to the shape of the tile. These voids, which can be bird houses, are advertised as allowing circulation of air which helps keep the attic cool, but during a fire the normally beneficial drafts can propel firebrands into the voids if there are openings greater than about $\frac{1}{8}$ th of an inch.

Spanish clay tiles are more susceptible due to the irregularities of the tiles and the lack of integrity of eave-closures/bird stops to enclose the ends. Some clay tile and cement tile roofs are capped or sealed with cement which over years can become loose and separate or fall out due to foot traffic, shifting, or settling. The edges and peaks of Spanish tile roofs are particularly susceptible. Roofs with interlocking panels such as stone coated steel or flat light cement tile are much less susceptible to firebrand invasion but still require some attention to proper sealing.

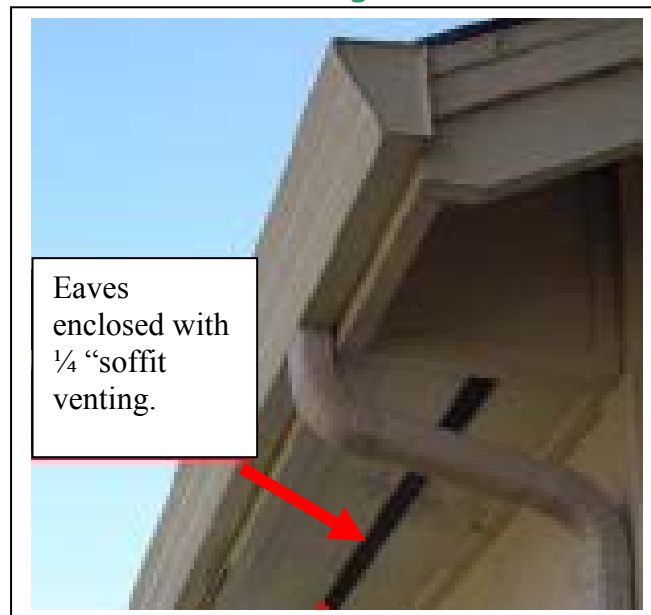
The wood under the eaves are also capable of catching firebrands due to spacing and loose fitting junctions of the material construction. These overhanging eaves should be enclosed and sealed with non combustible soffits (that word again) with 1/8th inch screen venting. The soffit vents inhibit fire entry but allow the attic to get the air circulation needed.
